Pothole Data Report

Diversified Pothole # **13**

Project Name: **Pena Blvd Potholing**

Addr./ Inter. **Pena Blvd / Jackson Gap**

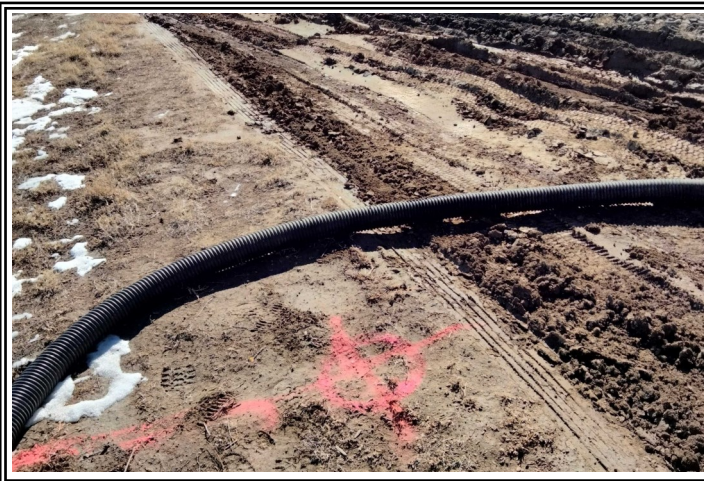
Before Photo

Utility Type: **Communication**
 Utility Material (if known): **PVC & 1/4" Tracer Cable**
 Utility Size: **4" x 4**
 Utility Direction: **North/South**
 Utility Color: **Gray**

Top of Utility: **44"**
 Bottom of Utility: **60"**

Type: **Dirt**
